Restoring a Fractured Central Incisor: A Challenge to Overcome

Restoring a single central incisor should aim at preserving the affected tooth as well as re-establishing function and esthetic. This clinical report describes a patient with compromised smile due to the fracture of the tooth number 11 which was immediately restored by resin waiting for the healing process after the trauma. A zirconia based ceramic restoration was performed. Basic guidelines were followed to guarantee a natural mimicry of the restoration.

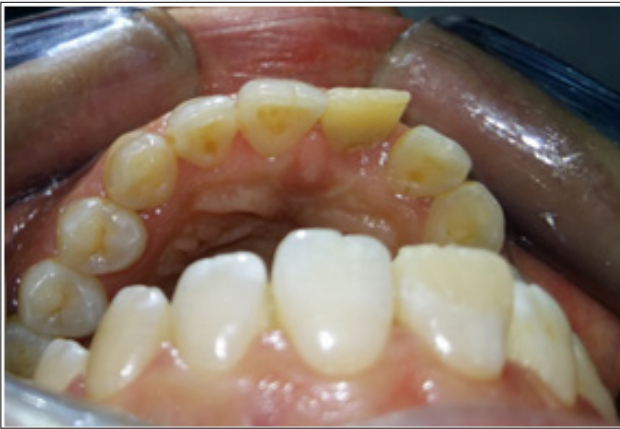
Figure 1: Initial case: the right central incisor was fractured at a lingual-distal angle just apical to the cemento-enamel junction. Palatal view of a large defective composite restoration in tooth 11.

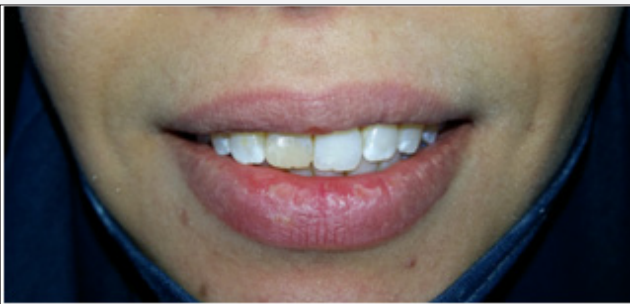
Figure 2 : The fractured central incisor restored with resin.

The tooth received a traumatic blow. To guarantee successful endodontic outcomes, adequate root canal system treatment was performed. In addition, a provisional composite was realized, providing immediate esthetic satisfaction. This was reliable short-term restoration of the crown-root fractured tooth during healing period and recovery of the periodontium (Figures 1 & 2) [16]. The patient's medical history was non-contributory. We required interacting with the patient to set expectations. First, the patient was recommended to take up initial periodontal preparation and to intensify oral hygiene before starting the rehabilitation process [17]. We proceeded by taking natural and full smile photographs with and without shade tabs (VITA 3D Master shade guide) Black and white digital images were used to select the correct value [17].

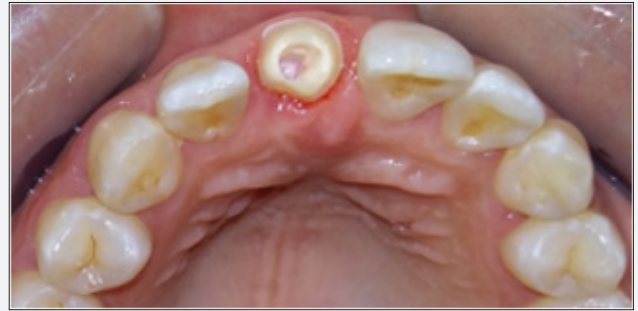
Gingivectomy using a new diamond-tipped bur was done to convert the sub gingival fracture to a supragingival one (Figure 3) [18].

Figure 3 : Preparation of the abutment: occlusal view.

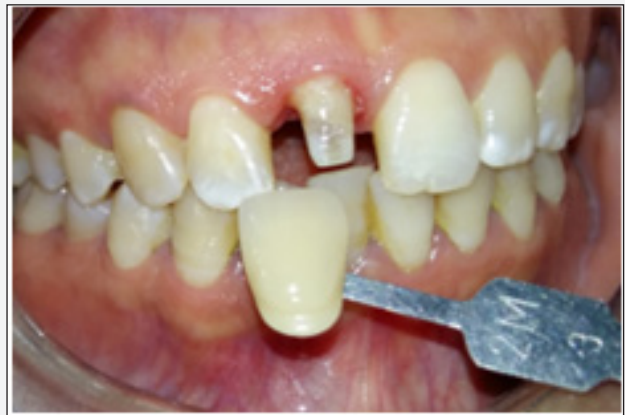
Figure 4 : IPreparation of the abutment: occlusal view.

a) Metal-free restorations require strict preparation techniques: Proximal walls are ideally tapered between 6 and 10°, they should be rounded with no sharp angles so as to avoid any internal stress in the crown. Moreover, margins should be extremely smooth and uniform to guarantee precise, well-fitting and strong ceramic ones. These principles of tooth preparation are meant to ensure good mechanical behavior of the ceramic material thus preventing fracture and cracking [11]. Once the preparations undertaken, temporary crown, with precisely fitting and highly polished margins, was fabricated utilizing the silicone matrix formed on the modified study model. It's a key to success in such cases [9]. A well-made temporary

crown will immediately satisfy the esthetic, functional and biologic requirements (Figure 4). Thus, time constraints may be removed. A retraction was made to allow the impression of additional tooth structure beyond the margins, so that we can help the technician create the correct emergence profile [4].

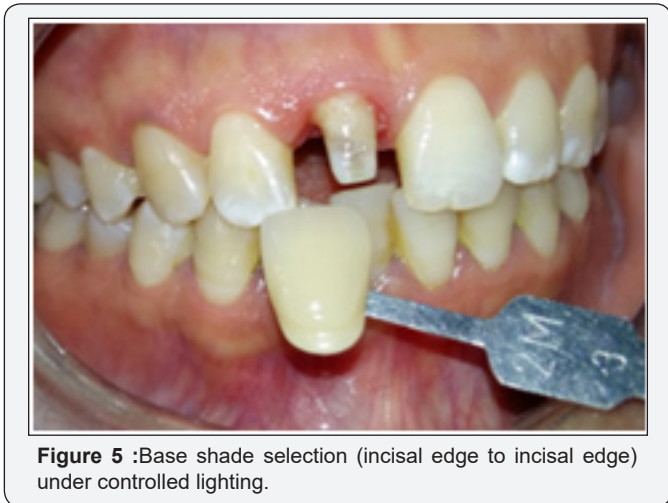
Accurate shade selection and shade matching are a paramount step for achieving natural mimicry of the central incisor (Figure 5). From an esthetic perspective, it may be the most difficult tooth to fabricate due to the association of many variables such as metamerism, individual characterizations and variations in lighting and illumination type [11,13]. If not regarded, they all contribute to reducing predictability of providing the desired shade [1,16,20]. This primordial step should be taken at the beginning of the impression appointment before tooth dehydrates and its color changes (become brighter). The reproduction of the shape is a similarly important parameter to achieve the perfect restoration. A shade map was drawn with all internal and external characterizations, variations in chroma and translucency, as well as irregularities of the incisal edge, Crack lines and incisal halo.

Figure 5 :Base shade selection (incisal edge to incisal edge) under controlled lighting.

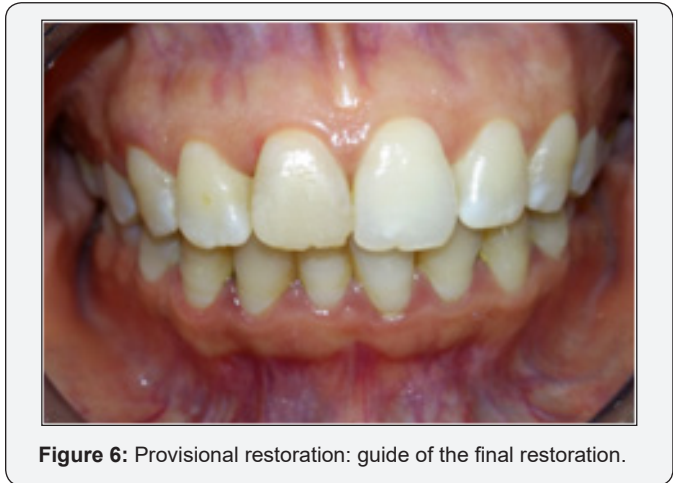
They all were identified, recorded and communicated to the dental ceramist. The level of reproduction of such features depends on the patient acceptance to guarantee the success (Figure 6) [1]. Besides the material used for the understructure, the layering porcelain was carefully selected. Occlusion was carefully checked and adjusted [18]. An esthetic try-in, before final staining and glazing, was carried out to verify the crown morphology and the color [17]. As the patient expectations were very high, this requires care, skills and talent of the restorative team [11]. Multiple try-INS is often required. We can even be forced to remake the crown until achieving a satisfactory result [4]. The ceramic crown was cemented using glass ionomer reinforced by resin which provides good seating besides sufficient working time, good fluidity and easy trimming [21]. At the end of the treatment, the patient was pleased with the results and no longer hides her smile (Figures 7 & 8).

Figure 6 : Provisional restoration: guide of the final restoration.
