Identification and GIS Analysis of Disasters Occuring in Landslide Prone Areas of Pakistan

Naseem Gilany* and Manzoor Hussain

School of Civil and Environment Engineering, National University of Science and Technology, Pakistan

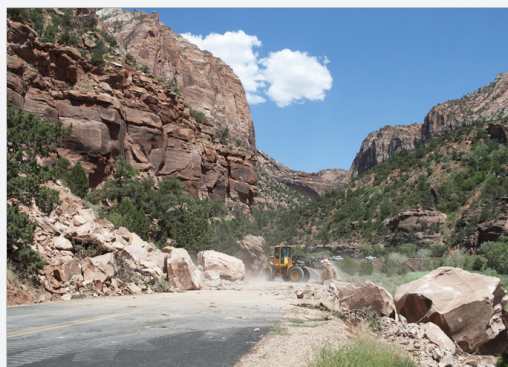
Figure 1: Rockfall on a road from the adjacent slope.

Rockfall. Rockfalls also occur in the study area. Because the natural slopes mostly contain soil deposits with some small to boulder size rock pieces present within the soil mass. It has been observed that such soil strata are highly susceptible to erosion. When water from the rainfall or snowmelt percolates into the soil, it softens up the soil strata. This results in reduction of soil strength thus dislodging the rock pieces and resulting in flow of such stones along the slope. In the process, some more rock pieces and debris from the slope also start flowing downslope. This process is rainfall and snowmelt related whereas no movement of rock pieces may be observed during dry period. Movement of some marginally stable rock pieces may also trigger as result of

earthquake. In some areas where rock mass is present along the slopes, disintegrated rock pieces also keeps on falling down from the slopes. Areas susceptible to the rockfall may be kept under strict observation, more vigilance be exercised, and drills may be practiced for taking shelter or escaping from such locations on triggering of rockfalls (Figure 1). Rockfall protective mesh / draping nets can be placed along the slopes susceptible to this phenomenon, if the source is limited (Figure 2).

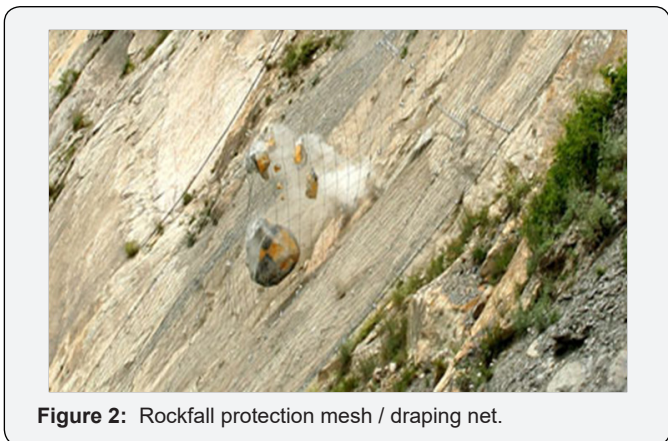
Figure 2: Rockfall protection mesh / draping net.

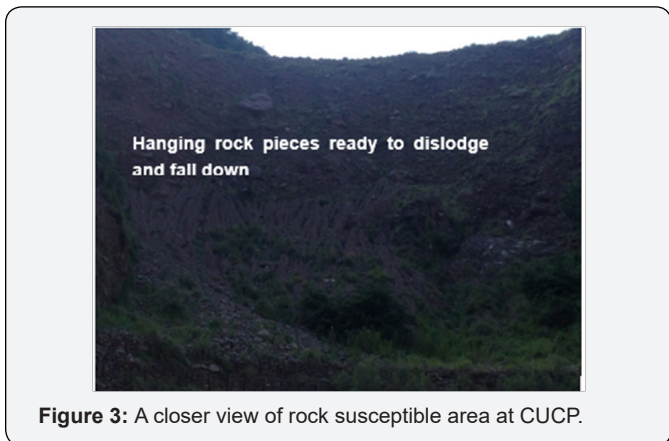
Figure 3: A closer view of rock susceptible area at CUCP.

Figure 4: 3D View of CUCP.

Observations and Discussion. The location is just in front of the bridge at Chakothi-Uri Crossing Point (CUCP) on Pakistani side of Line of Control. Well designed and constructed retaining structures are intact along the Uri-Chakothi Road. Reportedly, some rockfall phenomena occur during rainfall period. The fine-

grained soil is susceptible to erosion and scouring. Therefore, typical phenomena of rockfall as described before take place as result of wetting of soil especially during rainfall. Pieces of rock falls from the area near the top with relatively vertical face as marked on the photograph. A Check Post located on home side of the bridge is also vulnerable to the rockfalls. The length of road from bridge to the waiting area (reception point) on Pakistan side is also vulnerable to rockfalls phenomena (Figure 3 & 4).

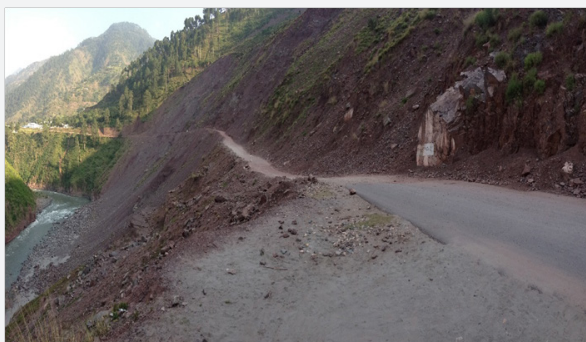
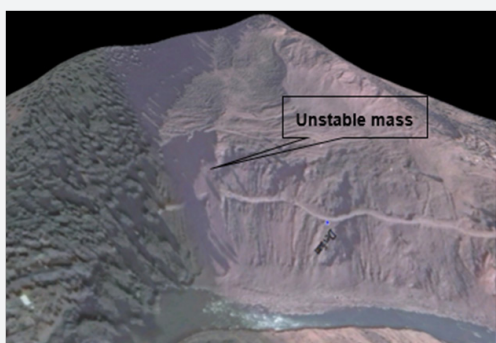
Devlian Landslide

Observations and discussion: Devlian landslide zone are an active landslide zone which is present along Muzaffarabad - Neelum Valley Road. The landslide affects about 300-400 meter of the road. The landslide occurred during 2005 Earthquake and is currently moving as a result of weathering of shale material. Shale is softened up upon interacting with the water. The weathered material slides along the slope and after hitting the road it goes down in the Neelum River (Figure 5 & 6). It is a major landslide which needs huge resources to mitigate it effectively.

Figure 5: Devlian landslide on Neelum Valley Road.

Figure 6: 3D View of Devlian Landslide.

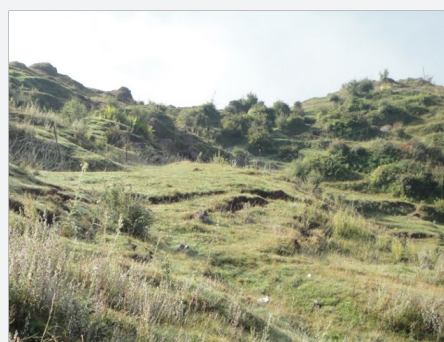
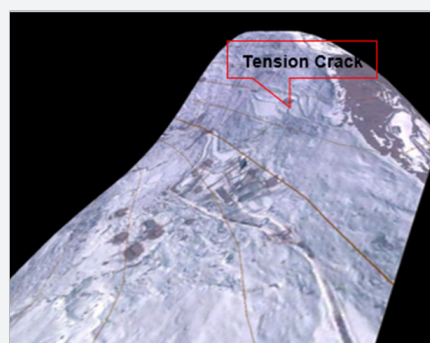
Observations and discussion: Nezapir are sited along a slope and is widely dispersed on the ridge. The location is under serious threat to landslide hazard. Evidences of landslide movement have been observed in the form of tension cracks on uphill side and movement near the slope toe. The tension cracks have undergone considerable widening and settlement in the order of few feet at the top scarp during rainfalls (Figure 7 &

8). It is determined that the translation landslide with shallow failure is the case at Nezapir. Some evidences of landslide movement have also been observed on downslope. The strata present along the slope mainly consist of fine-grained material. When a snowfall accumulates on the slope or water percolates into the slope during rainfall or snowmelt, driving stresses will increase considerably whereas the resisting strength which has already been reduced to residual level will remain the same. This increase in the driving stresses when exceeds the resisting strength will result in triggering the landslide movement. Therefore, probability of landslide movement will increase during and/or after heavy rainfalls and during snowmelt period. The observations suggest that the location is highly vulnerable to landslide hazard and is under serious threat. Layout, pattern, and series of tension cracks suggest that landslide is active, and movement is taking place may be at very slow rate. Rate of movement may increase as a result of heavy rainfalls and snowmelt or sudden failure may occur as a result of some tectonic activity (earthquake).

Figure 7: View showing a tension crack running about 400 m along the slope.

Figure 8: Digital Elevation Model (DEM) of Nezapir.
