Case Report

J Cardiol & Cardiovasc Ther

Micro-Bubbles in the Left Heart

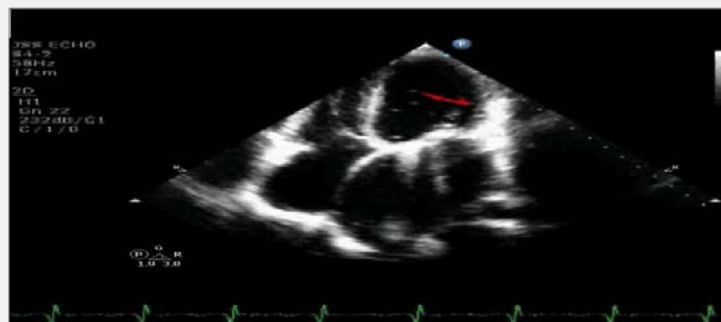
Figure 1: Transthoracic apical four chamber view showing micro-bubbles in the left ventricle.

atrium and left ventricles (Figure 1 & 2 and Video 1 & 2). They probably arose near the mechanical valve and were seen both in the left atrium and left ventricle. These microbubbles were not seen in left ventricular outflow tract and the aorta. He had undergone MVR (TTK Chitra heart valve 27mm) three years back when he was diagnosed to have rheumatic heart disease with severe calcific mitral valve stenosis in sinus rhythm and good bi-ventricular function. Following replacement intra-operative transoesophageal echocardiography and postoperative TTE screening showed normal prosthetic valve function with washing jets, mild pulmonary hypertension with good bi-ventricular function. No clots, vegetation or pericardial effusion. The micro-bubbles were not seen in these echo cardio-graphic evaluations.

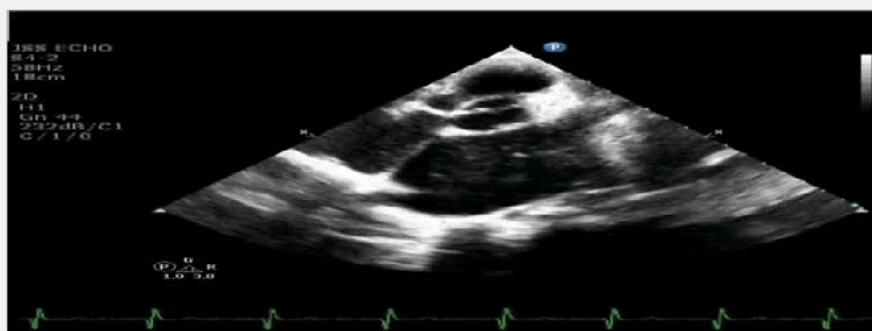
Figure 2: Transthoracic parasternal aortic valve short axis view showing micro-bubbles in the left atrium.

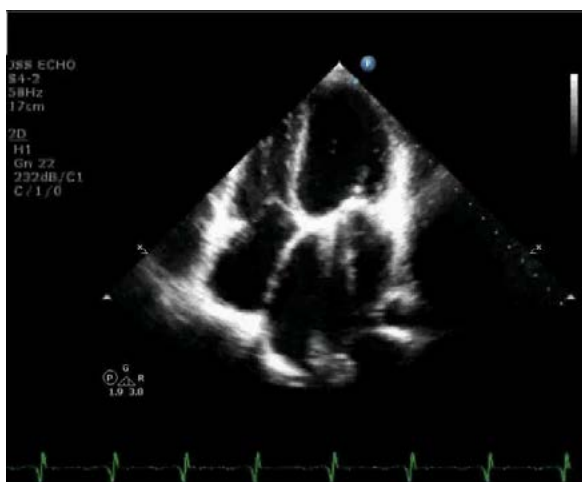
Video 1: Transthoracic apical four chamber view showing micro-bubbles in the left ventricle.

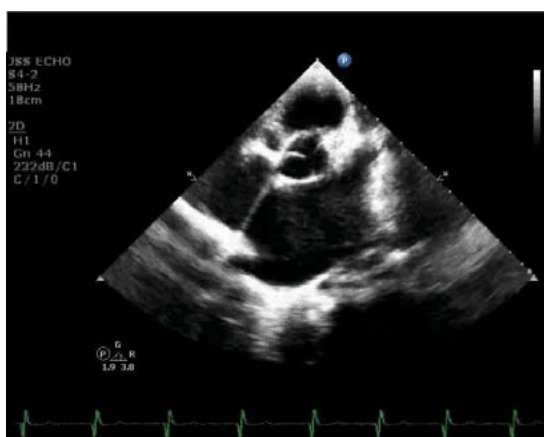
Video 2: Transthoracic parasternal aortic valve short axis view showing micro-bubbles in the left atrium.

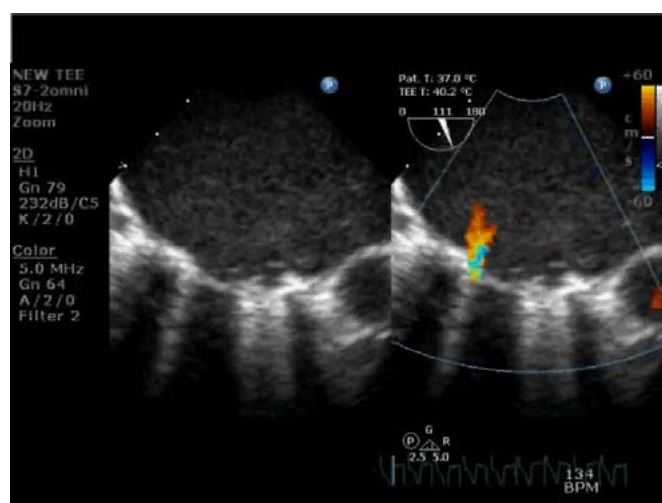
Video 3: Transoesophageal zoomed mid-oesophageal four chamber view with colour compare showing micro-bubbles originating from the prosthetic mitral valve.

Careful evaluation of the images showed that micro-bubbles were arising from the prosthetic valve, when the occluder is closing against the sewing ring. There was no pericardial effusion which ruled out left atrial rupture. CT scan did not reveal any fistula between the left atrium and bronchus or oesophagus. TEE also showed that micro-bubbles were seen in the left atrium and left ventricle (Figure 3 and Video 3). Normal prosthetic valve function. No pannus or vegetation. Mean gradient across mitral valve was 9mm of Hg. Good bi-ventricular function.

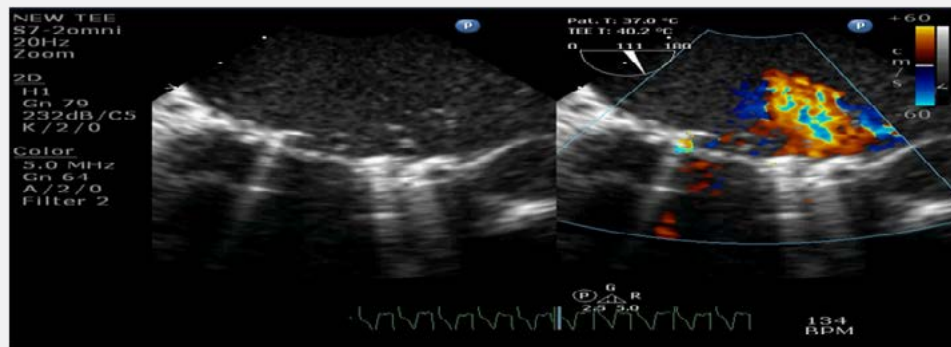
Figure 3: Transoesophageal Mid-oesophageal zoomed four chamber views with colour compare showing micro-bubbles in the left atrium.
